FATIGUE BEHAVIOR OF CORROSION NOTCHED
WEATHERING STEEL SAMPLES

A Thesis Submitted to the Faculty of
The College of Engineering and Computer Science
in Partial Fulfillment of the Requirements for the Degree of
Master of Science

Florida Atlantic University

May 2014

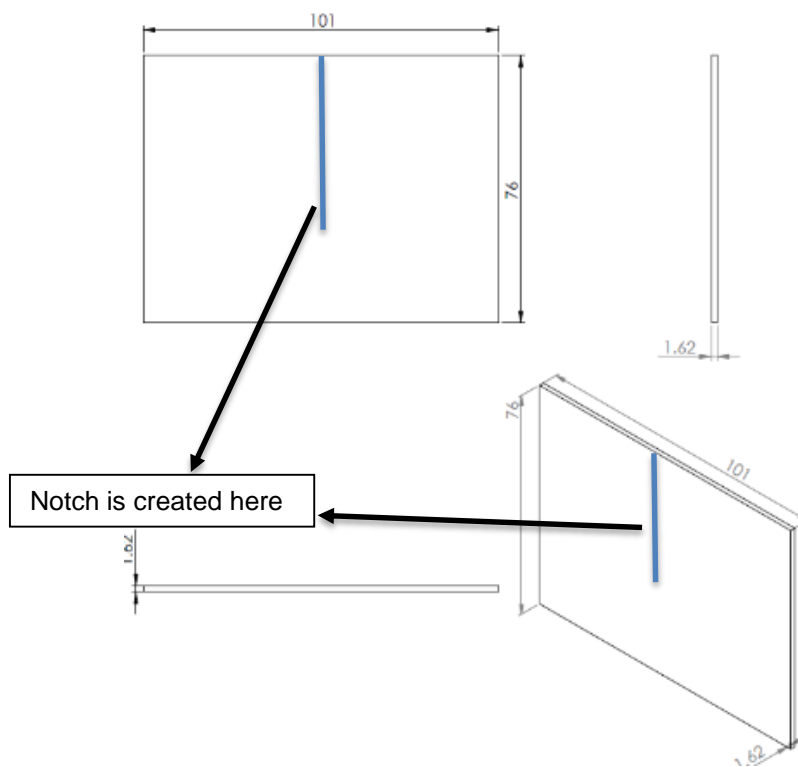
The samples in this thesis study were plates made of weathering steel described in section 3.1. Their dimensions were 101 x 76 x 1.62 mm as shown in the SolidWorks plan below. All the samples were cleaned by sand blasting. This process eliminated the existing corrosion products. Then the samples were dipped in methanol, drained on clean laboratory paper and dried with hot air for 2 minutes to prevent water condensation. Then all the samples were labeled by permanent marker. The objective of this first phase was to create notches of appropriate breadth in the middle of the each plate's surface in a short amount of time by corrosion. These plates with notches were cut into smaller pieces in order to perform static and fatigue tests on them in the second phase of this study.

Figure 7 Sample dimensions and notch location

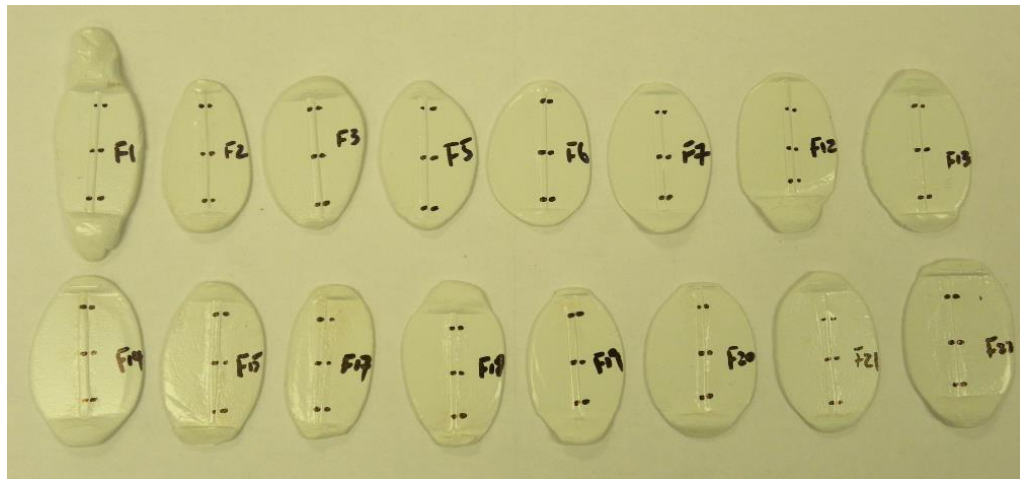
To accurately shape the notches and to keep records, all the notches were molded by epoxy putty to illustrate their volumes as shown below. They were labeled with a permanent marker.

Figure 18 Molds for WS samples

The depths of the notches or the remaining thicknesses of the samples were deduced from these molds. As shown in Fig. 19, the photo of the mold of sample F7, a bump can be seen in the middle. This is the mold of the notch. Therefore, the thickness of this bump is the corresponding notch's depth. This is obtained by the difference of the thickness of the mold at the top of the bump (location A) and the thickness at the flat surface around (location B). These two thicknesses were measured by a digital caliper.

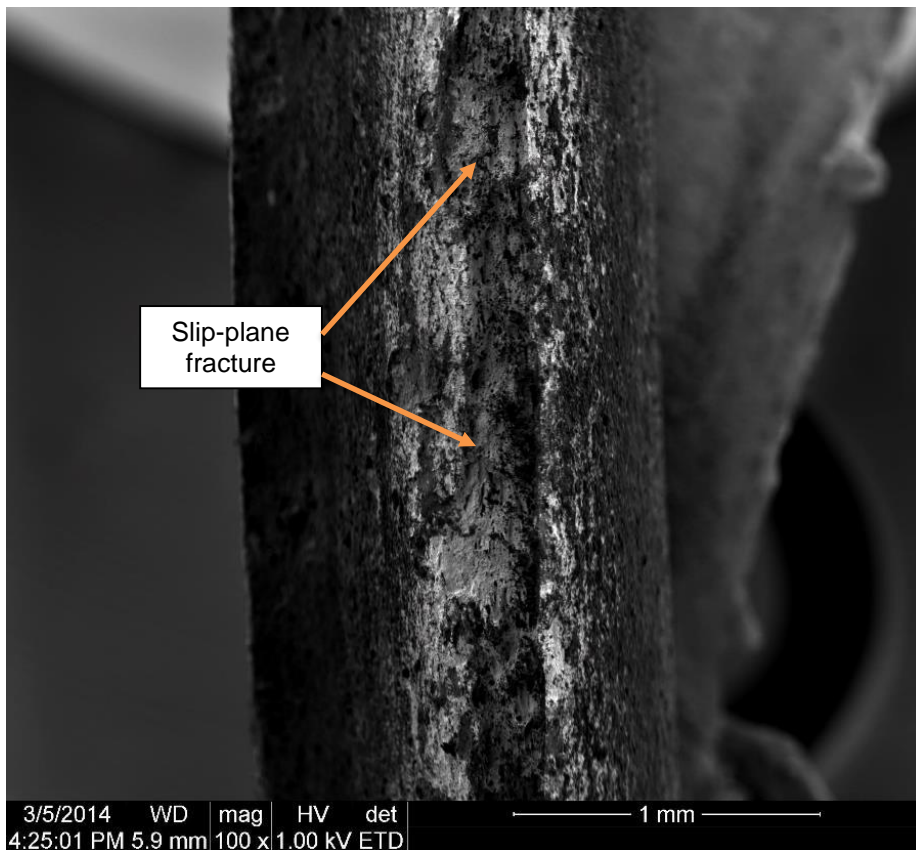
Figure 83 SEM fractograph at location b) of F6. 100 X.

This graph shows typical slip-plane fracture, where the angle caused by stress can be observed.
