CORROSION INITIATION AND PROPAGATION ON CORROSION RESISTANT
ALLOYS EMBEDDED IN CONCRETE BY ACCELERATED CHLORIDE
TRANSPORT

A Thesis Submitted to the Faculty of
The College of Engineering and Computer Science
in Partial Fulfillment of the Requirements for the Degree of
Master of Science

Florida Atlantic University

August 2013

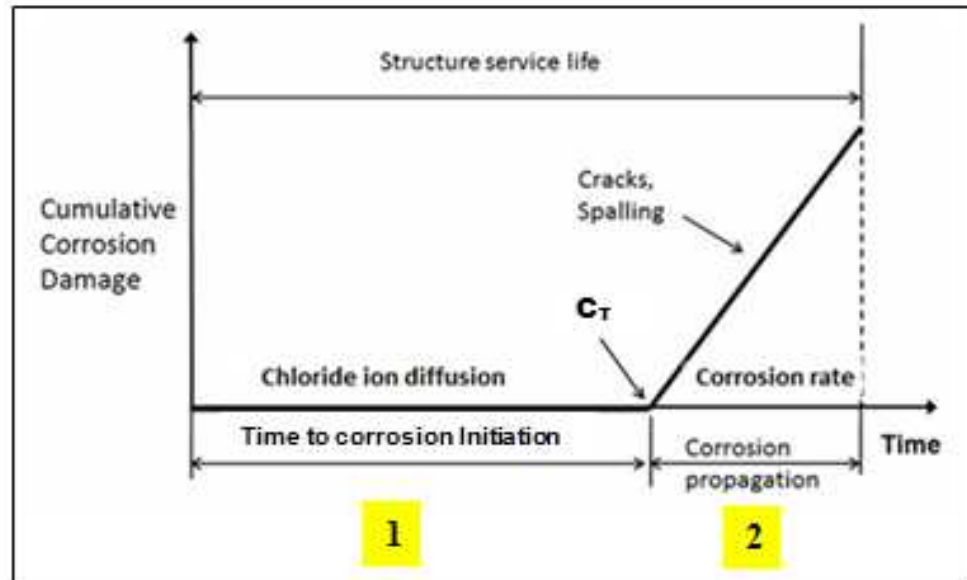
Figure 1 Schematic illustrations of the initiation and propagation stage in reinforced concrete [1]

Corrosion of the reinforcing steel due to chloride ions is a major problem that bridges and other structures face when exposed to marine environments. There are two periods that model the service life of a reinforced concrete structure: 1) time to corrosion initiation, (once a critical chloride threshold concentration (C_T) is exceeded) and 2) corrosion propagation stage [1] [2]. The time to corrosion initiation of corrosion resistant alloys (CRAs) embedded in concrete is expected to be significantly longer than for carbon steel. The prolonged time to corrosion initiation is due to the high C_T of these alloys. CRAs have the property of resisting higher concentration of chloride reaching the surface of the reinforcement before corrosion initiates; than typical reinforcing steel alloys used (such as carbon steel [1] [2]). Once C_T is exceeded corrosion initiates. Then, the corrosion propagation stage begins.

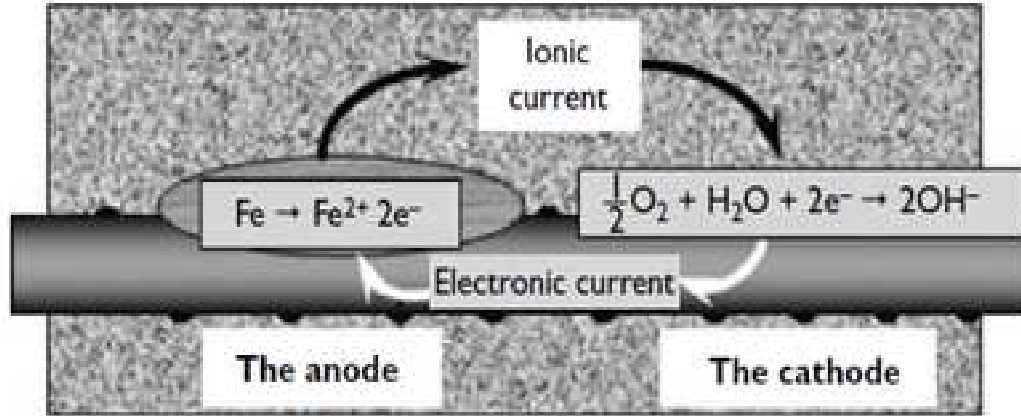
Figure 2 Schematic representation of the electrochemical reaction steel/concrete

IV. Finally, in order for the circuit to be complete the flow of current inside the concrete electrolyte from the anodic regions to the cathodic regions, transport of ions in the pore solution takes place.

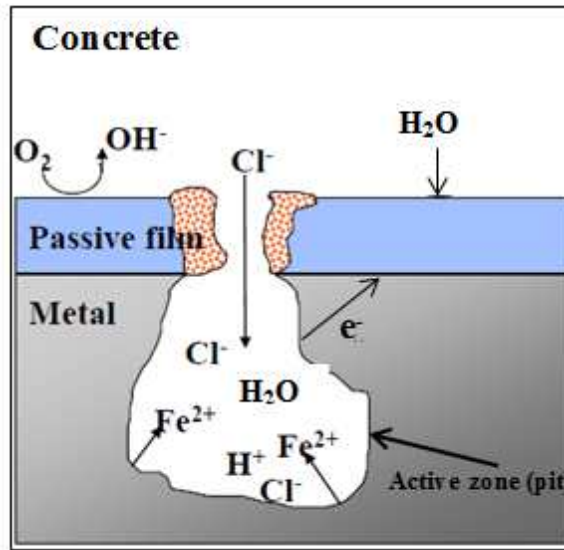
Figure 3 Schematic representation of pitting corrosion of steel in concrete

by the passive film act as anodes (active zone) with respect to the surrounding still passive areas where the cathodic reaction (primarily the oxygen reduction reaction (ORR) takes place). It has been reported that the ORR is slower in stainless steel alloys [12]. Figure 3 shows the morphology of the pitting attack.

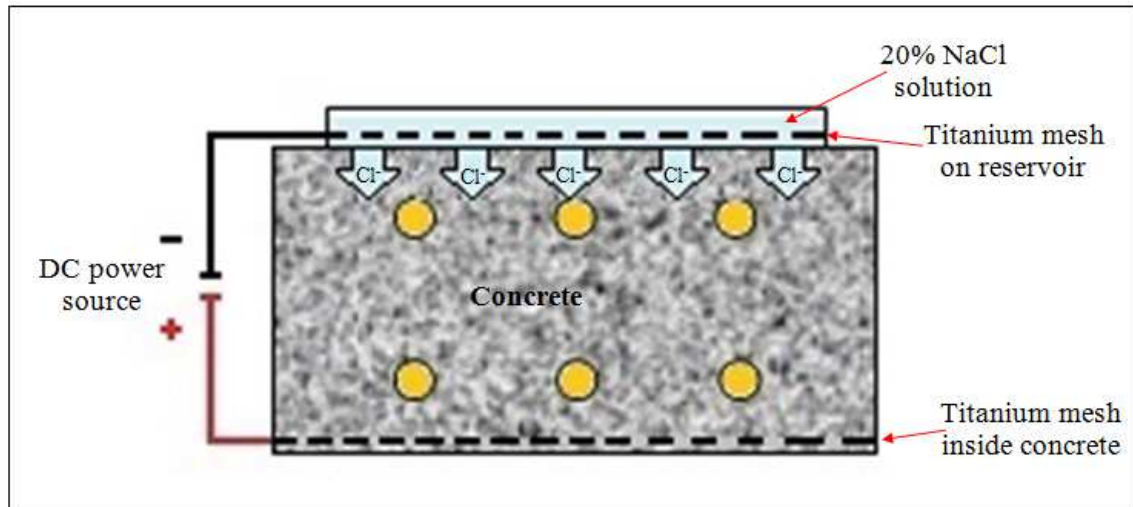
Figure 4 schematic representation of the migration test

Electrical current flow from ion migration in concrete is important for electrochemical rehabilitation techniques like chloride removal and for our case to accelerate chloride transport so that C_T can be reached in a short period of time.

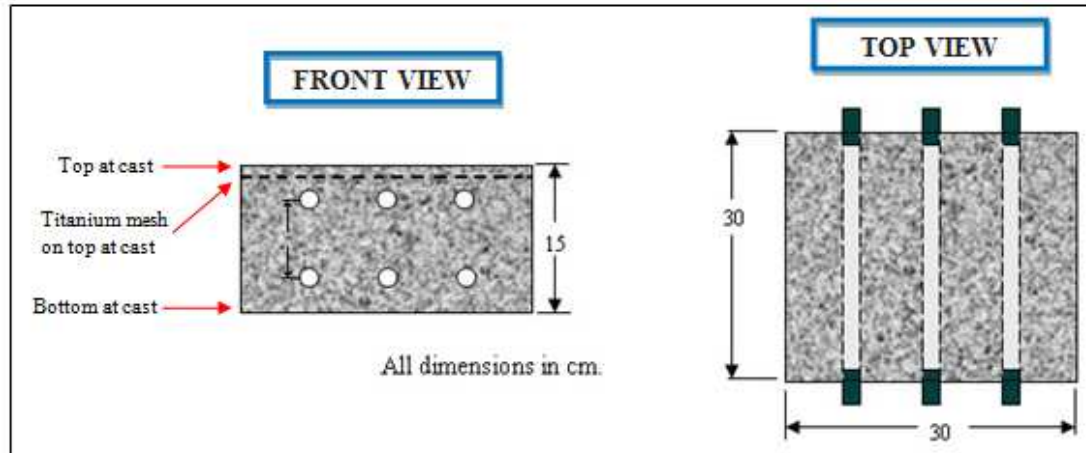
Figure 5 Specimen at cast

The first batch is named batch-1 and the second batch is named batch-2. Six specimens per batch were casted, which consisted of five specimens with 6 rebars and one blank specimen (i.e. with no rebar).

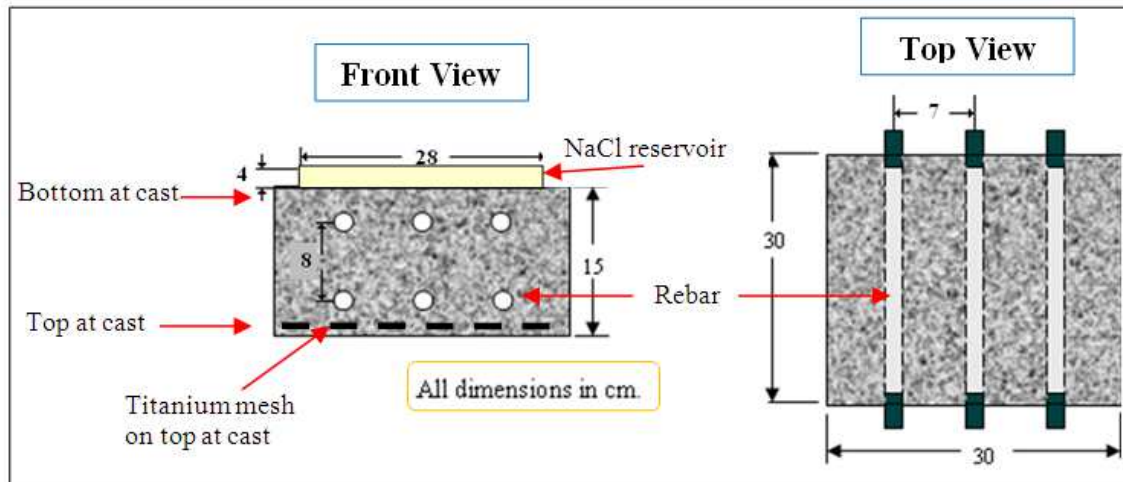
Figure 6 Sample schematic, dimensions and specifications

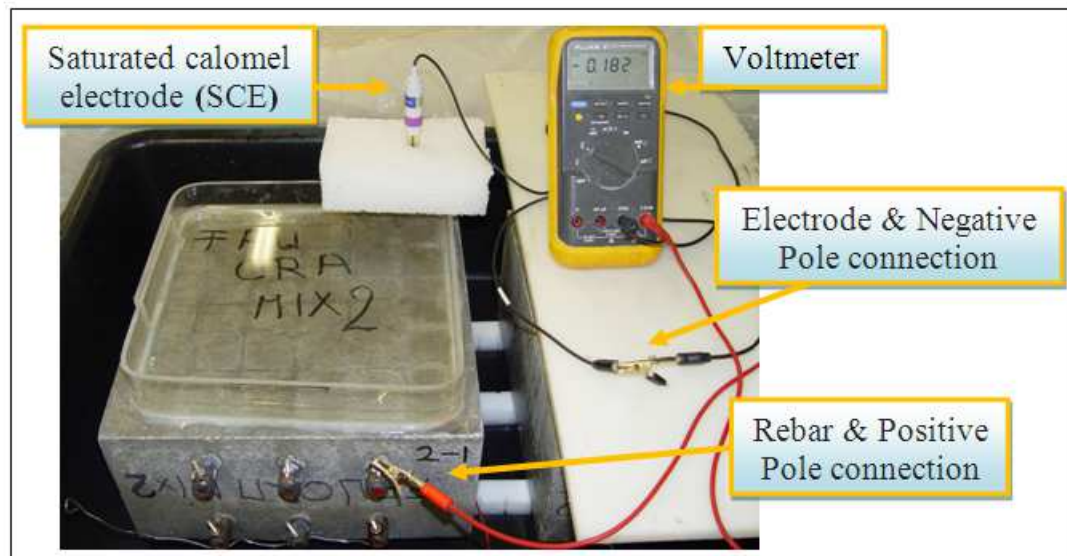
Figure 8 OCP measurement components

named A, B, C and for the three bottom interconnected-rebars. The readings were made with a high impedance voltmeter and a saturated calomel electrode (Figure 8). Linear polarization was performed only once during this period on selected specimens and on selected rebars.

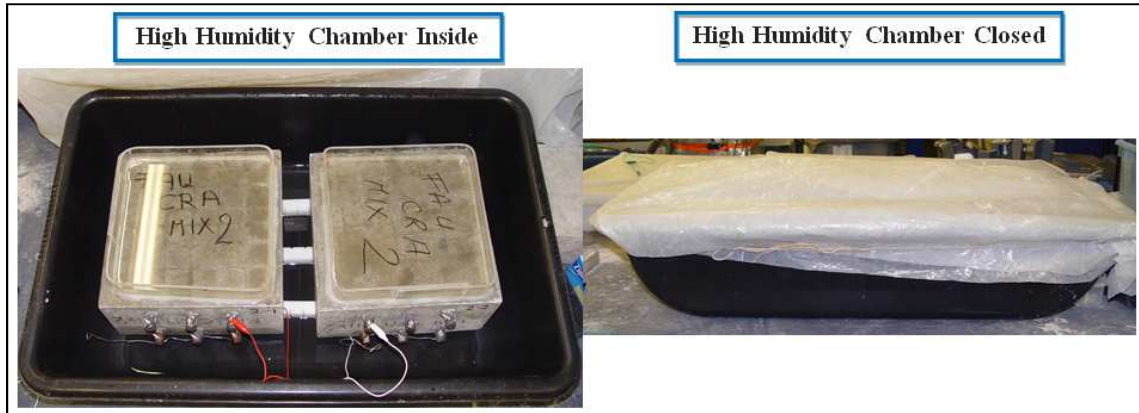
Figure 9 High humidity chamber

specimens were sprayed with water every day for 7 days to increase the moisture content of the concrete. This wetting continued during phase II as required (usually twice per week). It is very important that the specimens are as saturated as possible prior the application of the electric field method in order to have an efficient chloride to transport via migration [15].

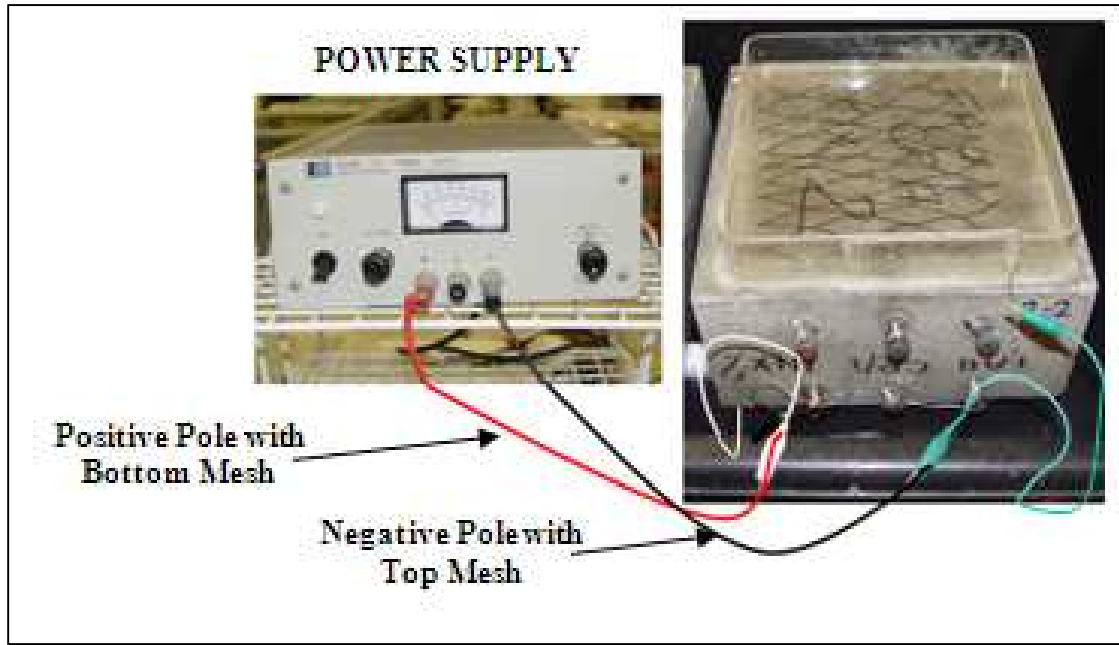
Figure 10 Electric field set up

monitor the off potential evolution and to identify when corrosion might have initiated. Table 12 in appendix (A) displays the applied voltage schedule showing the days when the electric field was applied for each specimen.

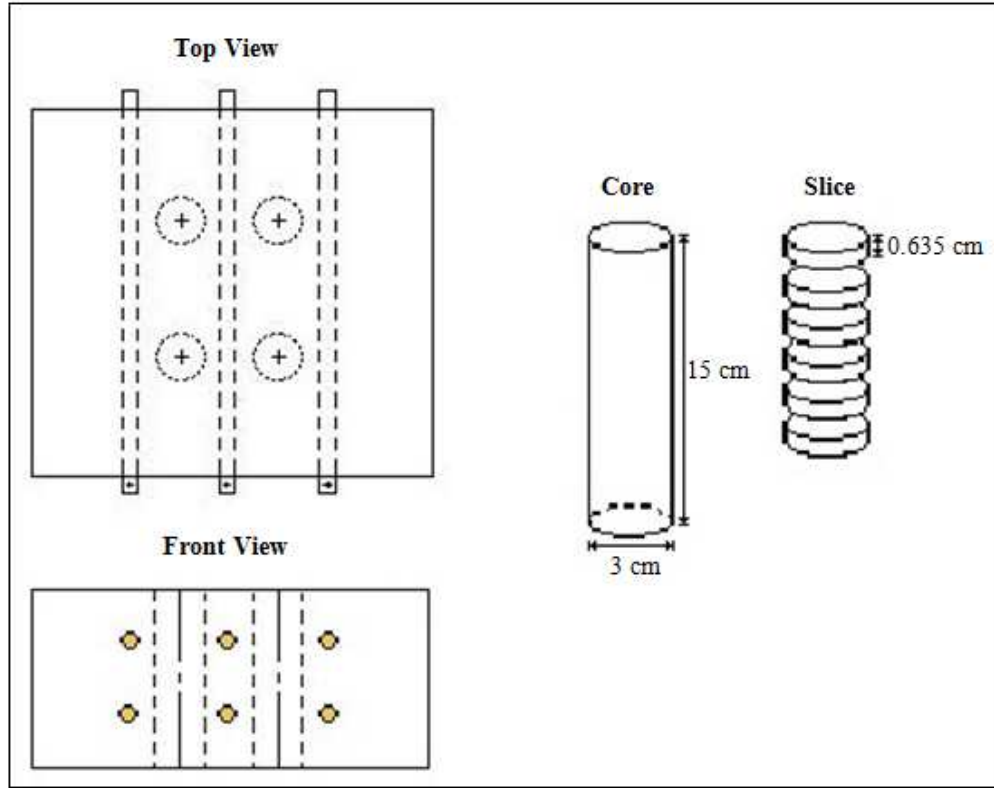
Figure 11 Cores cuts and dimensions

1. Testing/exposure was terminated, the solution in the reservoir removed, and the acrylic reservoir removed,
2. Four (or two) cores were obtained from in between the rebars on the empty space where no rebars are on the way. Each core is drilled from the top surface all through the bottom surface of the specimen as shown in Figure 11. The obtained cores were 3 cm in diameter.
3. Two of the cores (one per each side) were sliced for chloride profiles. Six slices were obtained with a wet saw. Each slice was marked every 0.635 cm (actual slice is thinner due to thickness of the blade). Then each slice was pulverized to perform chloride analysis.

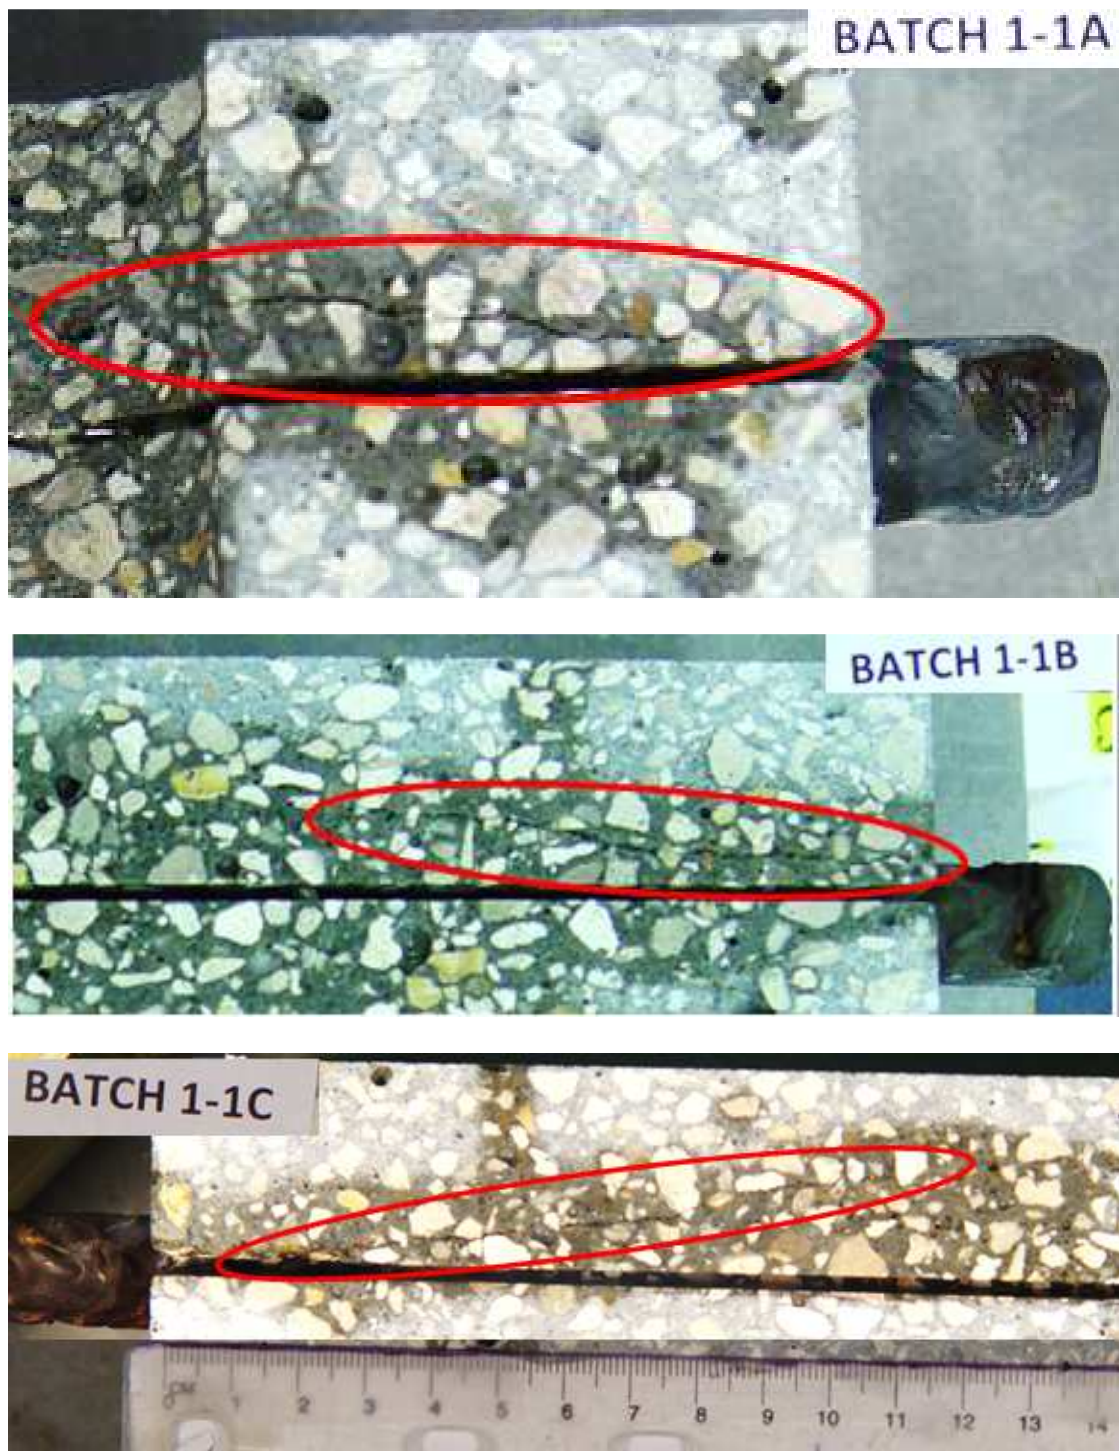
Figure 22 Lateral cracks pictures for specimen Batch 1-1

the crack was all across segment that contains rebar B) and extended to the other segments that contain rebars A and C.

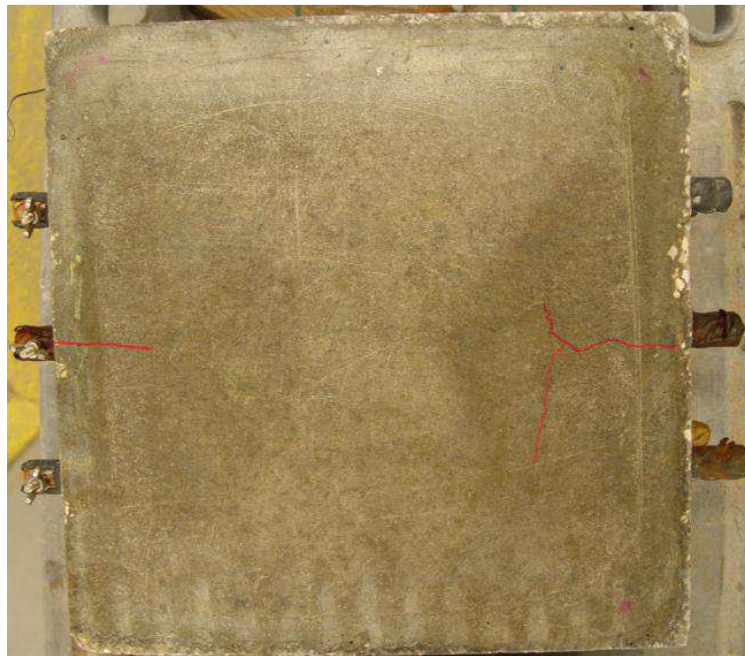
Figure 24 final crack picture of specimen batch 1-2

All the other specimens of batch-1 (1-3, 1-4, 1-5) have visible crack(s) when inspected on day 162. During the inspection performed on day 200 all of the visible cracks observed on day 162 have grown over time. Figure 47 in Appendix (A), shows how the crack maps evolved with time for every batch-1 specimens (except for batch-1-2 specimen which was terminated on day 158).

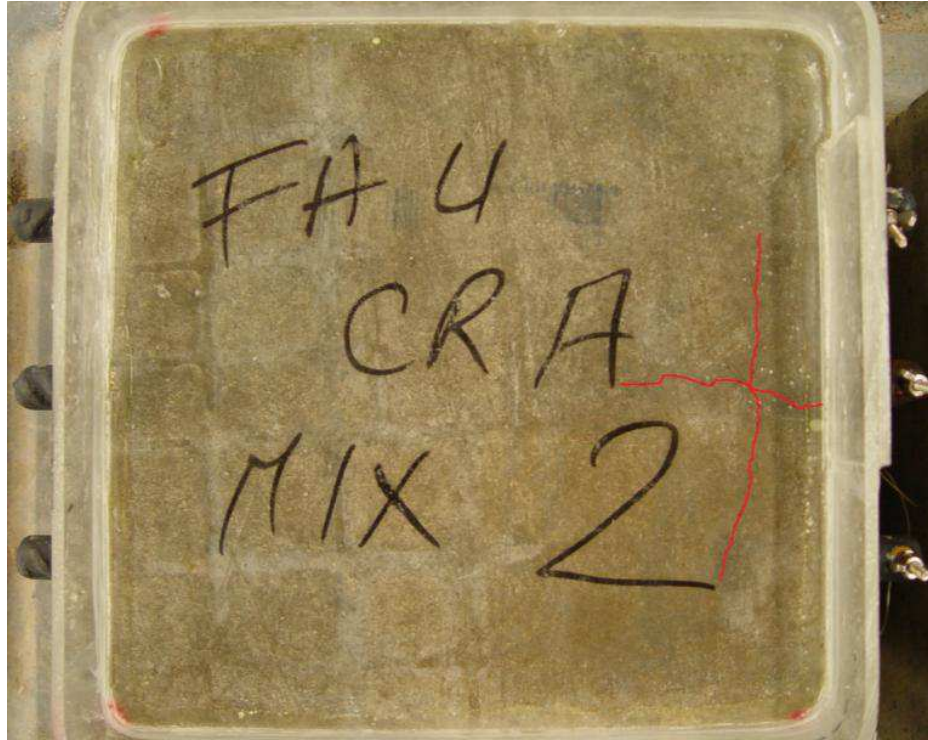
Figure 25 final crack picture of specimen batch 2-2

As indicated above, specimen Batch-2-1 showed one crack on each side (approximately 4 cm long each one) above and along rebar B (center rebar). These cracks were visible during the inspection performed on day 162; during subsequent inspections (up to day 185) the cracks lengths remained the same. Specimen Batch-2-3 showed no cracks during the initial inspection (day 162) nor after the inspection done on day 186. Sample 2-4 showed one crack on rebar B, approximately 7 cm long on the inspection done on day 162; after inspection done on day 185 the crack remained the same length. Sample 2-5 showed no cracking at the initial inspection (day 162); but during the final inspection on day 185, it showed a crack approximately 5 cm long. Figure 47 in Appendix (A) shows the results of the crack propagation for every specimen per inspection day for batch-2 (except for specimen Batch-2-2).

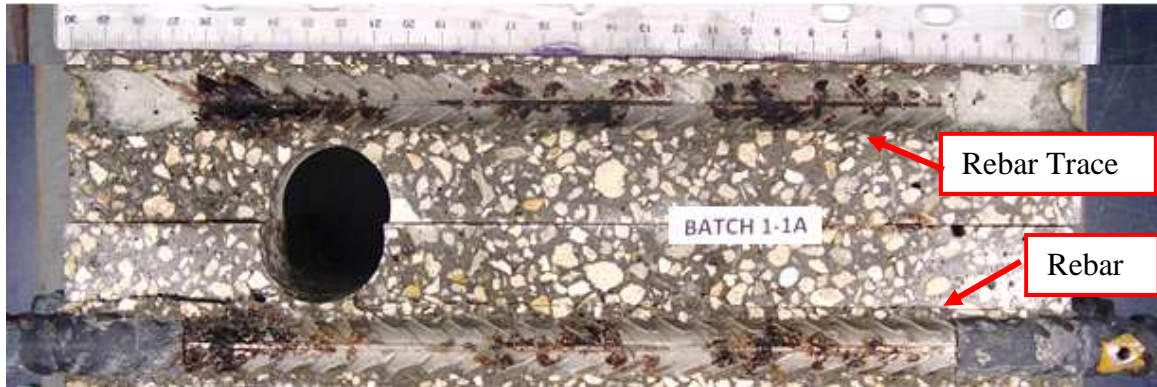
Figure 26 (a) shows a top view of rebar A. The picture shows the corrosion products observed upon exposure of the top surface of this rebar. The corrosion products have a dark brown and black color. Spots of corrosion products are observed almost all along the rebar; but, it has three large spots: on the left (largest of the three), on the middle, and on the right. Rebar B corrosion extent is shown in Figure 26 (b). The corrosion products have a dark brown and black color. The corrosion on this rebar extends from the left side all the way to the middle of the rebar and covers all the top surface about (11 cm long and 1 cm width). This rebar is the one that has most corrosion products and likely the rebar that caused the crack observed on the surface. Corrosion products observed on Rebar C are shown in Figure 26 (c). The corrosion products have a dark brown and black color. The corrosion is almost all along the rebar, but except for a large corrosion spot on the left, the other corrosion sites consisted of smaller spots than those observed for Rebars A and B. The biggest corrosion spot is on the left side of the rebar (about 5 cm long and 1 cm width). The back side of each rebars A, B, and C showed no corrosion. The condition of the three bottom rebars is shown in Figure 48 in the appendix. No corrosion products were observed on these rebars. It is suggested that the chloride concentration above the bottom rebars did not exceed C_T ; so, corrosion did not initiate at this depth (concrete cover about 10.5 cm).

(a) Autopsy and visual examination picture of specimen batch 1-1 rebar A

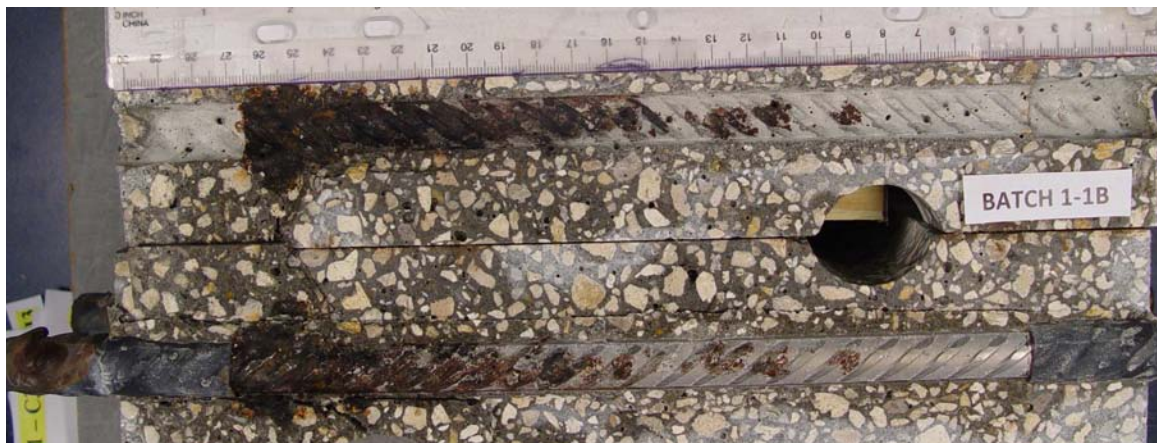
(b) Autopsy and visual examination picture of specimen batch 1-1 rebar B

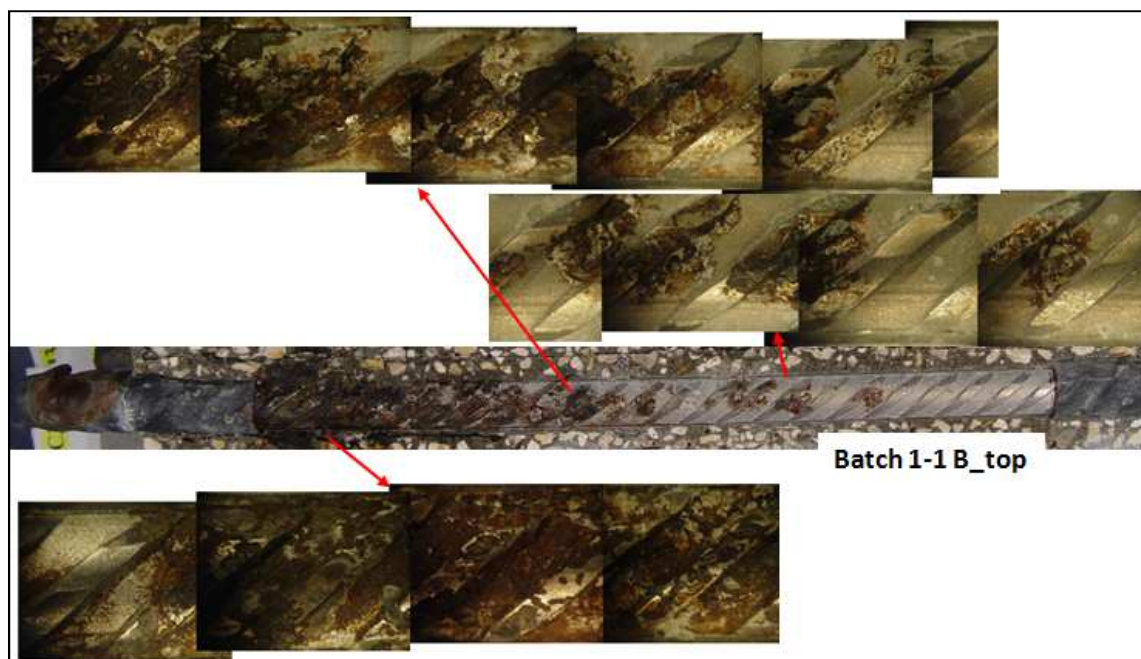
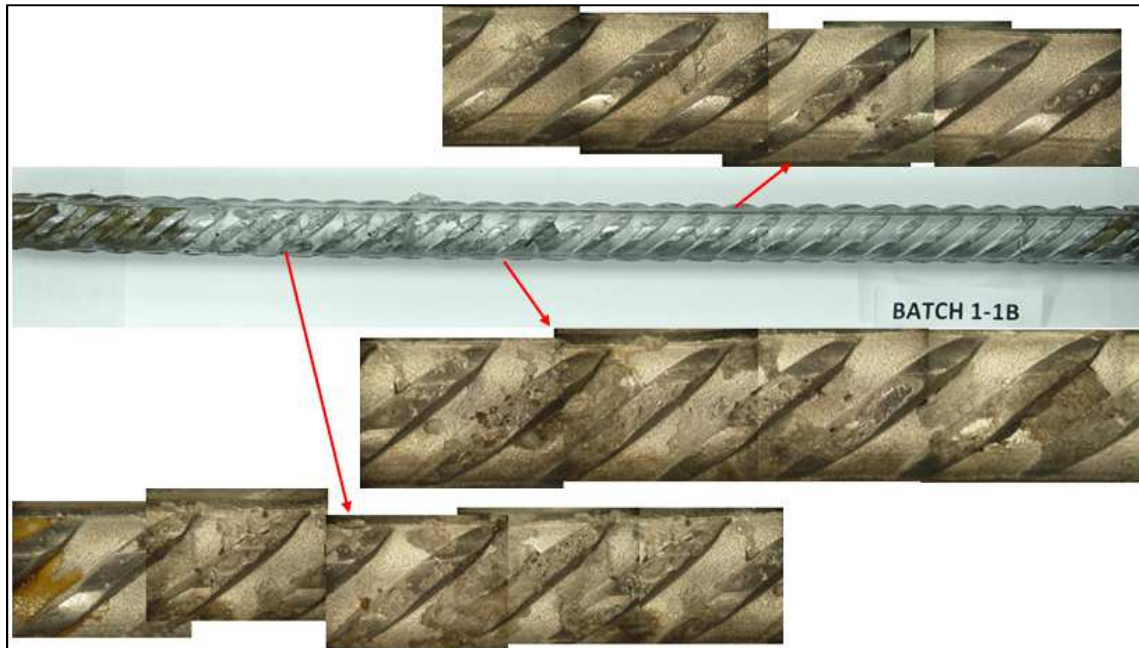
The corrosion products on the rebars were partially cleaned with a plastic brush and then cleaned as per ASTM G-01. Figure 27 shows the surface of rebar B (batch 1-1 specimen) after brushing and after acid cleaning. The top part of the picture shows the corrosion on the surface of the rebar; but, without the excess of corrosion products. After cleaning, pitting corrosion on the rebar surface was observed of various size and depths (Figure 27 bottom). Here we can see the craters where the pitting corrosion took place. Figure 49 and Figure 50 in the appendix (A) shows close-up pictures after cleaning for rebars A and C respectively of batch 1-1 sample; similar form of corrosion was observed for these rebars, but to a lesser extent.

(a) Picture of Batch 1-1B after cleaning with a plastic brush

(b) Picture of Batch 1-1B after cleaning as per ASTM G-01

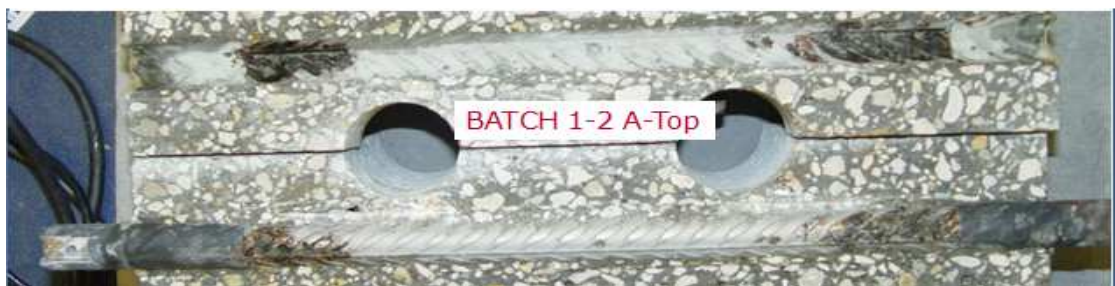
sites. The corrosion spot on the right side of therebar is (4.5 cm long and 1.1 cm width), and the other is (2 cm long and 0.8 cm width). No corrosion spots were observed upon inspection on the back side of each rebar (not shown).The condition of middle bottom rebar is shown in Figure 28 (d). For this rebar, located at depth of 10.5 cm corrosion did not take place. The condition of all bottom rebars is shown in Figure 51. No corrosion products were observed on these rebars. It is suggested that the chloride concentration above the bottom rebars did not exceed C_T ; so, corrosion did not initiate at this depth (concrete cover about 10.5 cm).

(a) Autopsy and visual examination picture of specimen batch 1-2 rebar A

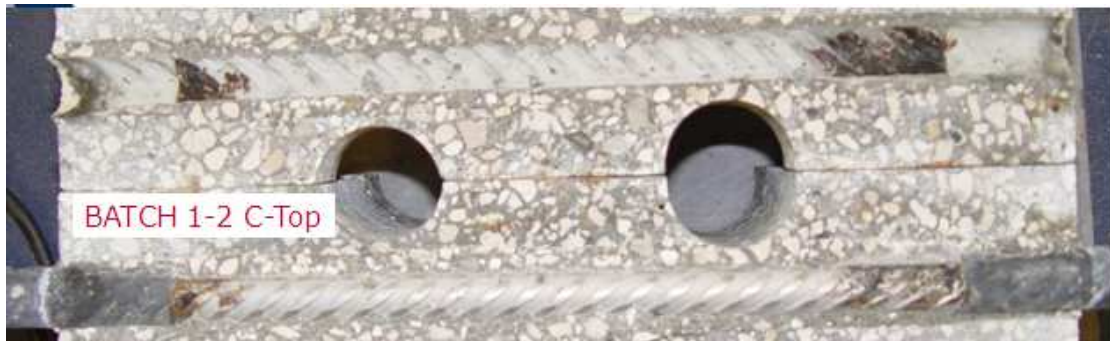
(c) Autopsy and visual examination picture of specimen batch 1-2 rebar C

Specimen batch 1-2 was selected for autopsy because the measured values of OCP and LPR suggested that corrosion had initiated. Figure 28 shows pictures of the rebars taken within a few minutes after opening the sample. These pictures capture the extent of corrosion Figure 28 (a) shows a top view of rebar A. The picture shows corrosion products on two sites of this rebar. The color of the corrosion products is black on both side; the dimensions are: right side (5 cm long and 1.2 cm width) and the other site (4 cm long and 1.2 cm width). Rebar B corrosion extent is shown in Figure 28 (b). The rebar have two corrosion sites, left side is (7 cm long and 1.2 cm width) and the other is (5 cm long and 1 cm width). The corrosion product on this rebar is completely black color. Rebar C corrosion extent is shown in Figure 28 (c). Rebar C has two corrosion

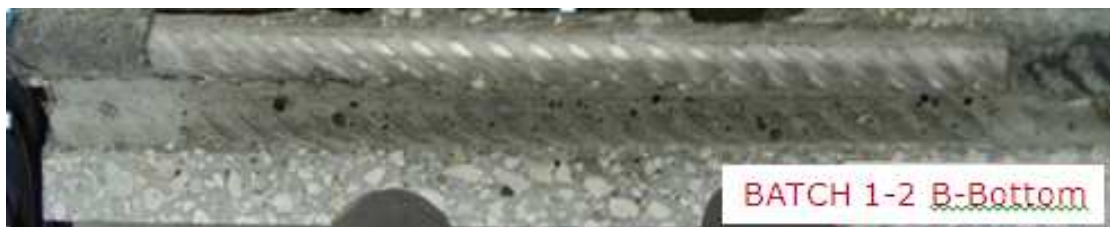
Figure 28 Autopsy and visual examination of batch 1-2

(d) Autopsy and visual examination of specimen batch 1-2 middle bottom rebar

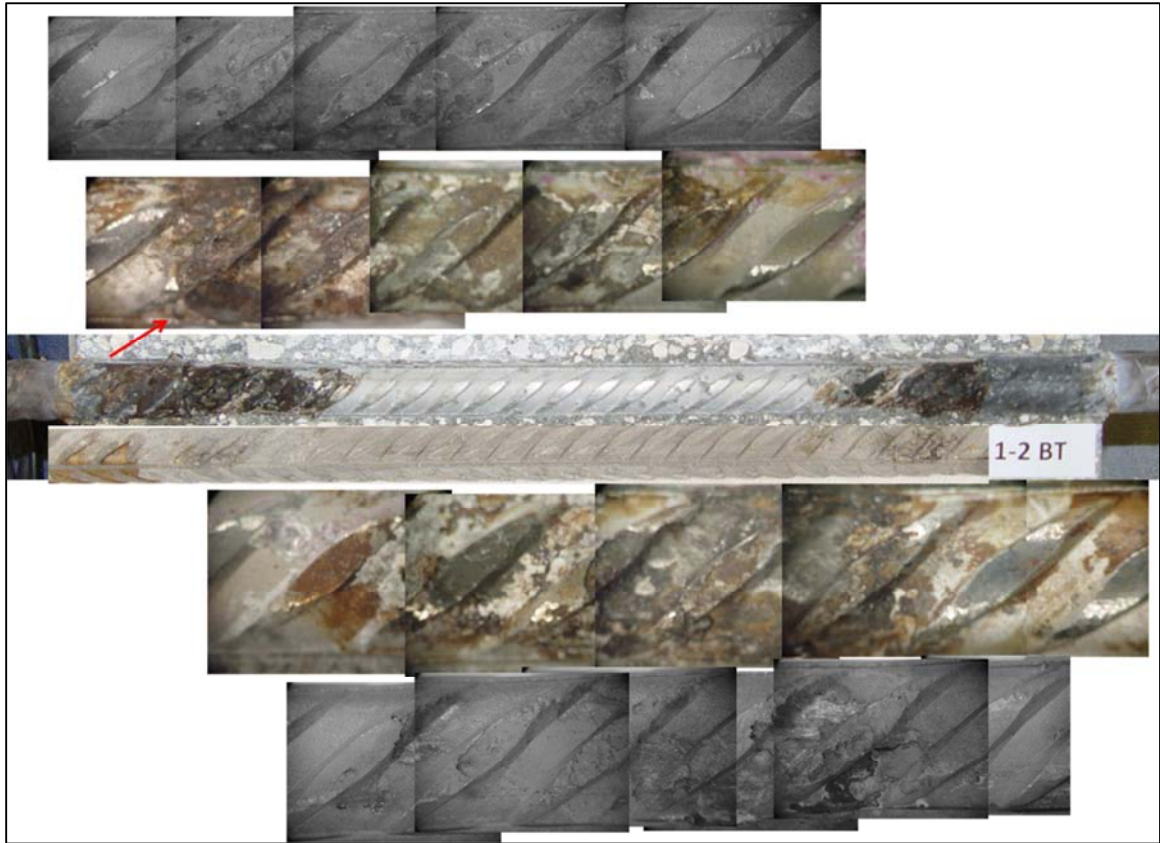
The surface of the rebars with corrosion product was cleaned with a plastic brush and then cleaned as per ASTM G-01. Figure 29 shows the surface of batch 1-2 B rebar after brushing and after acid cleaning. Figure 29 shows in color pictures the corrosion on the surface of the rebar after brushing it. After acid cleaning, pitting corrosion on the rebar surface can be seen as shown in Figure 29 by the collage of pictures in gray scale. Here we can see the craters where the pitting corrosion took place. Figure 52 shows close-up picture for batch 1-2 specimen rebars A and C after cleaning; similar form of corrosion was observed for these rebars, but to a lesser extent.

Figure 29 Close-up picture of sample batch 1-2B rebar before and after cleaning

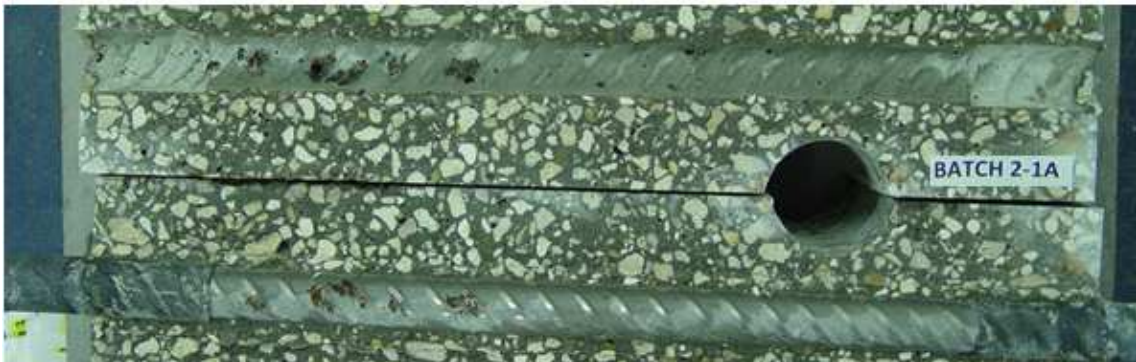
side of the rebar. Rebar B corrosion extent is shown in Figure 30 (b). The corrosion products have a dark brown and black color. This rebar have corrosion products in both sides but the right side is the largest (about 4 cm long and 1 cm width). Rebar C corrosion propagation is shown in Figure 30 (c). The corrosion products have a dark brown and black color. The corrosion spots are found almost all along the rebar length. The biggest corrosion spot is on the left side of the rebar (about 6 cm long and 1 cm width). The condition of the three bottom rebars are shown in Figure 53 in the appendix. No corrosion products were observed on these rebars. It is suggested that the chloride concentration above the bottom rebars did not exceed C_T ; so, corrosion did not initiate at this depth (about 10.5 cm).

(a) Autopsy and visual examination picture of specimen batch 2-1 rebar A

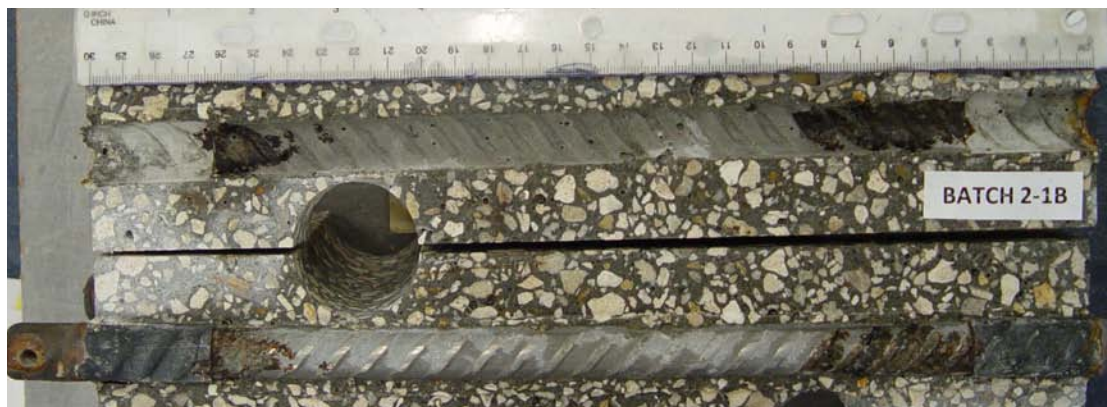
(b) Autopsy and visual examination picture of specimen batch 2-1 rebar B

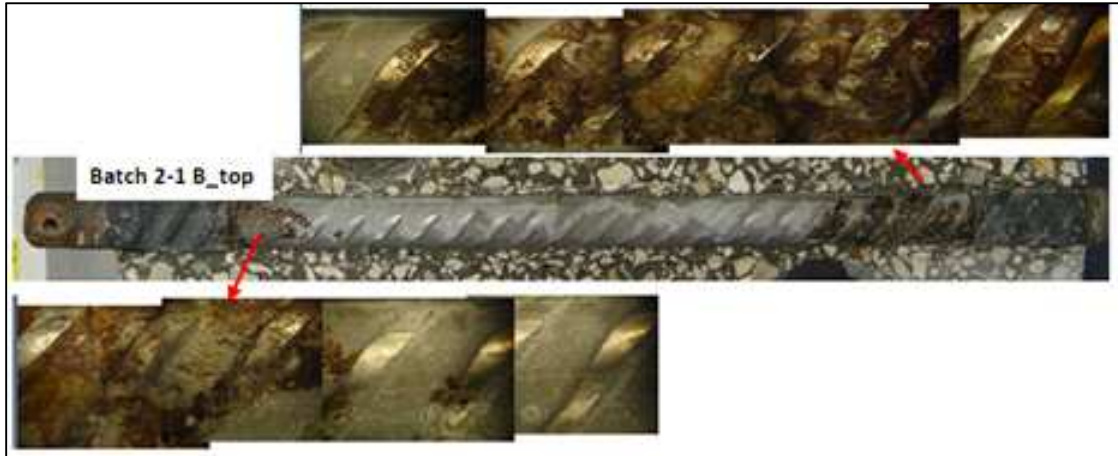
The rebars surface with corrosion product was cleaned with a plastic brush and then cleaned as per ASTM G-01. Figure 31 shows the surface of batch 2-1B rebar after brushing and after acid cleaning. Figure 31 (a) (top part of the figure) shows corrosion on the surface of the rebar after brushing it. After acid cleaning, pitting corrosion on the rebar surface can be seen as shown in Figure 31 (b) (the bottom part of this figure). Here we can see the craters where the pitting corrosion took place. Figure 54 shows close-up pictures for batch 2-1 sample rebars A and C after cleaning; similar form of corrosion was observed for these rebars. However, the corrosion was less than that observed on rebar 2-1B

(a) Picture of Batch 2-1B after cleaning with a plastic brush

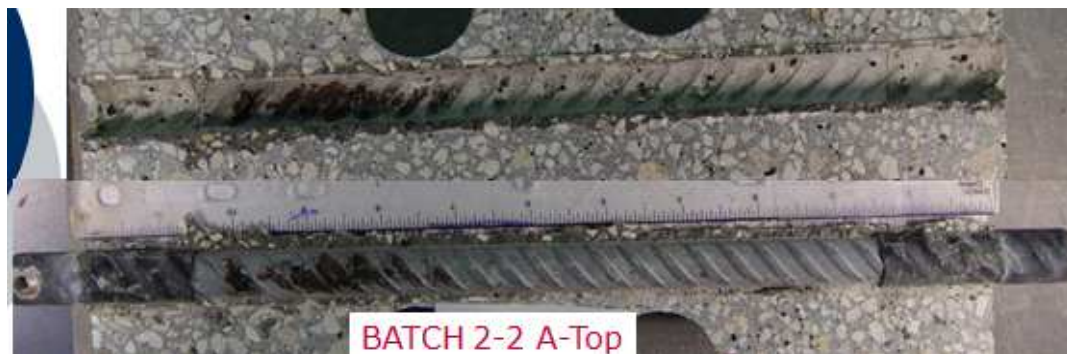
on this rebar. The corrosion products were black, about 5 cm long and it was located about 2 cm from the shrink wrap. Corrosion extent on rebar B is shown in Figure 32 (b) and it was the largest of the three top rebars. The corrosion on this rebar had a black color. Rebar C corrosion is shown in Figure 32 (c). Rebar C had corrosion only in one side but is away from the plastic heat shrink tubing. The corrosion site was very small and appears to have just initiated. The condition of bottom rebars is shown in Figure 55 in the appendix. No corrosion products were observed on these rebars. It is suggested that the chloride concentration above the bottom rebars did not exceed C_T ; so, corrosion did not initiate at this depth (about 10.5 cm).

(a) Autopsy and visual examination picture of specimen batch 2-2 rebar A

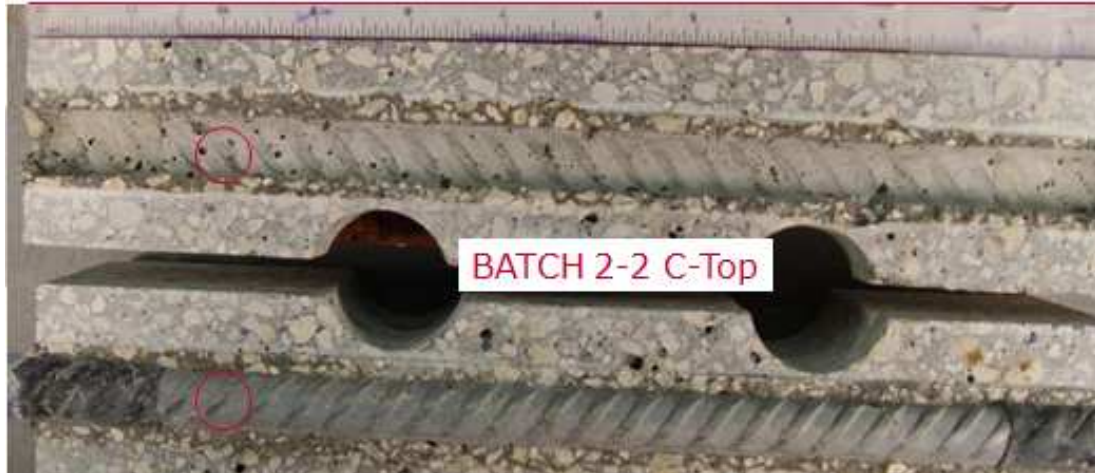
(c) Autopsy and visual examination picture of specimen batch 2-2 rebar C

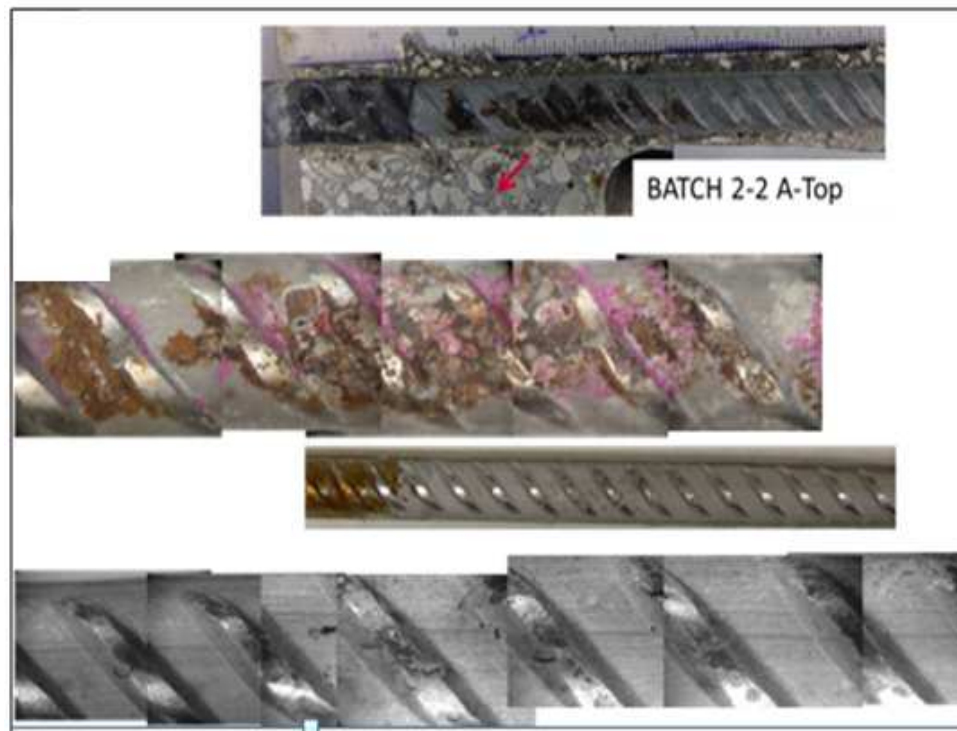
Figure 34 Close-up picture of sample batch 2-2 A before and after cleaning

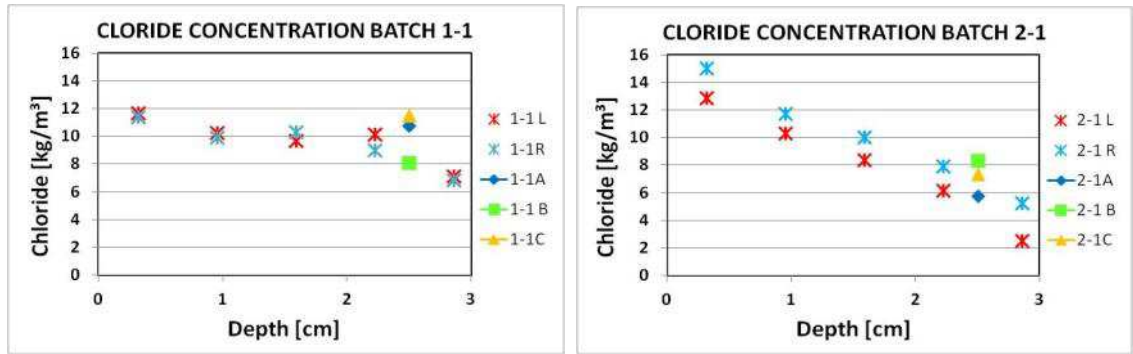
Figure 35 shows on the plot on the right side the chloride profile and the chloride at the rebar trace for batch 2-1 specimen. As expected the chloride content of the cores is decreasing as a function of depth. The chloride content measured at the trace of rebar A and C was higher compared (as suggested by previous research [22]) to the concentration measured from the core at the same depth (2.5cm). The chloride concentration measured at the trace of rebar A was slightly lower. This could have been caused by the concrete heterogeneity and also the chloride migration reached higher concentrations at some areas of the concrete than others (due to the meshes shape). It is important to point out that chloride transport also depend on the pore structure and tortuosity.

Figure 35 Chloride profile for specimens batch 1-1 and 2-1

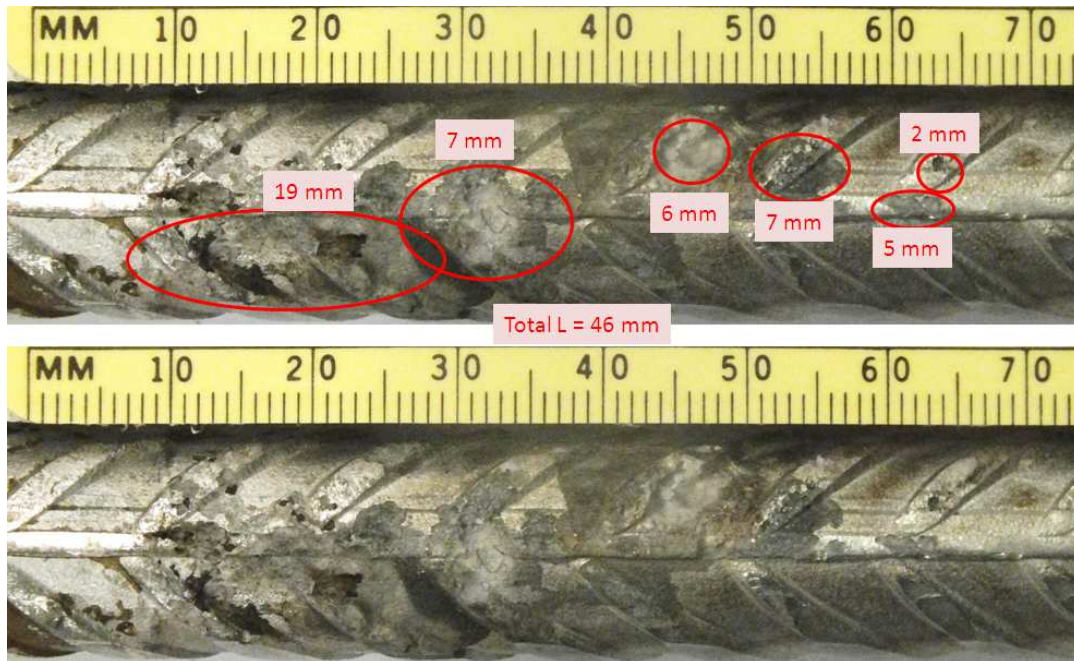
Where C is the concrete cover depth, \emptyset is the rebar diameter assuming cylinder shape of the rebar, and L is the length of the corroding segment. For our investigation the L value was obtained from measurements on the rebar side where the crack was observed, and from the summation of the different length of each small pitting corrosion spots that were observed to be deep enough to contribute to the crack formation. An illustration of how L value was obtained for specimen 1-1 rebar C (46 mm) is shown in Figure 36. The top picture shows the corrosion spots circled in red and the bottom picture is the same image without the circled spots.

Figure 36 Observed length L and value explanation process for specimen 1-1 rebar C

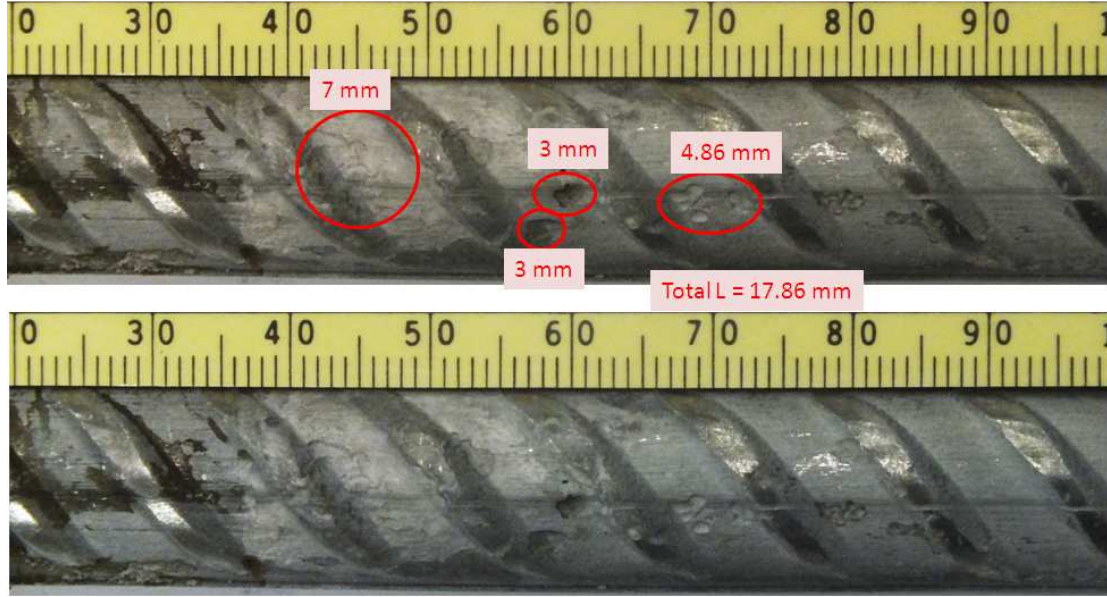
Figure 37 shows an illustration of the area where the measurement for L was obtained for rebar 2-2 B (17.86 mm). The top picture shows the corrosion spots circled in red and the bottom picture is the same image without the circled spots.

Figure 37 Observed length L and value explanation process for specimen 2-2 rebar B

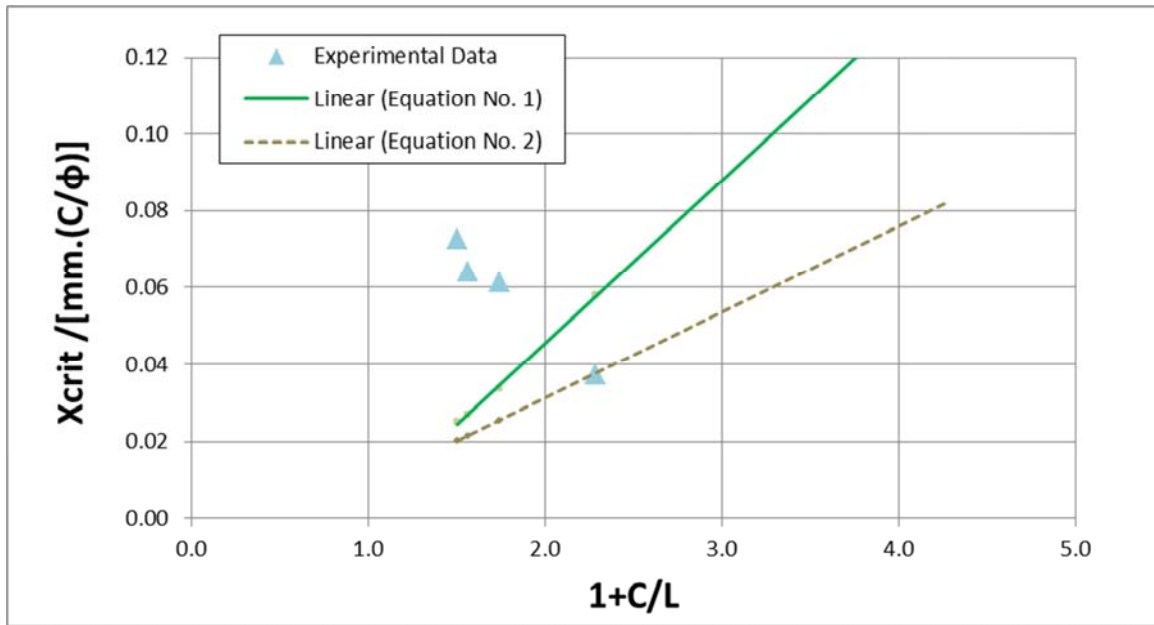
than 2 the X_{crit} is similar to the values suggested by equation (2). The larger X_{crit} values can be caused because in our experiments the corrosion was more localized (corrosion was observed only on one side of the rebar and in most areas it did not cover all the top rebar surface width) whereas the empirical equations assume that corrosion is uniform along L .

Figure 38 Plot of the X_{crit} values for equations (1), (2) and experimental results as a function of C/L ratio
