CORROSION INITIATION AND PROPAGATION ON CORROSION RESISTANT
ALLOYS EMBEDDED IN CONCRETE BY ACCELERATED CHLORIDE
TRANSPORT

A Thesis Submitted to the Faculty of
The College of Engineering and Computer Science
in Partial Fulfillment of the Requirements for the Degree of
Master of Science

Florida Atlantic University

August 2013

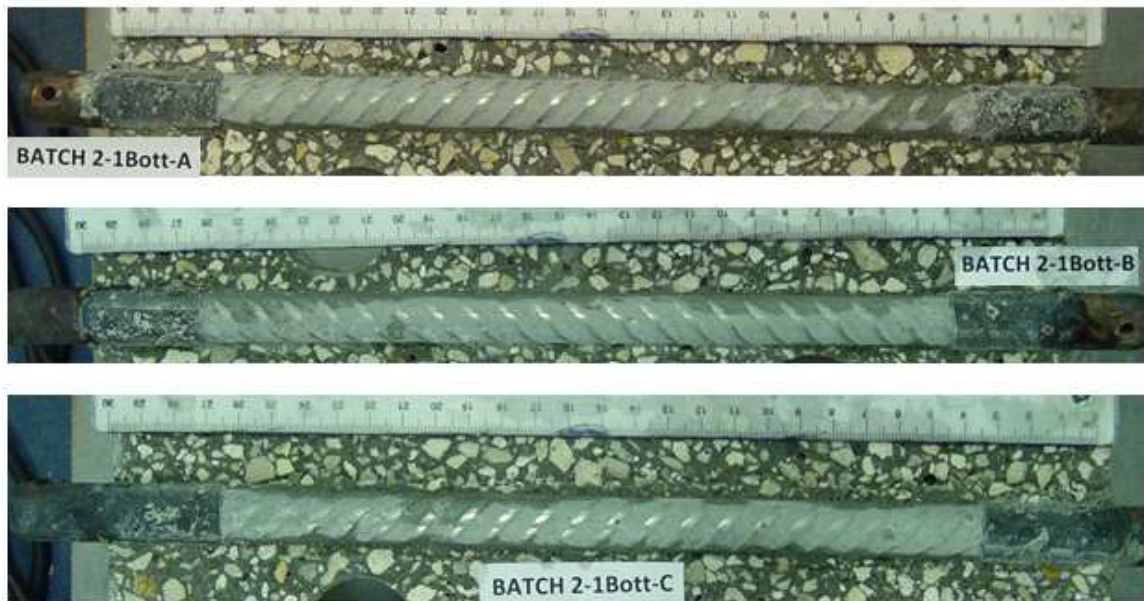
Figure 54 Close-up pictures before and after cleaning for batch 2-1
